**FAILURE CHARACTERISTICS OF SCS-6/Ti-24Al-11Nb
COMPOSITE WITH A CIRCULAR HOLE
AT ROOM AND ELEVATED TEMPERATURES**

THESIS

**Joseph E. Overbeck, Captain, USAF
AFIT/GAE/ENY/91D-8**

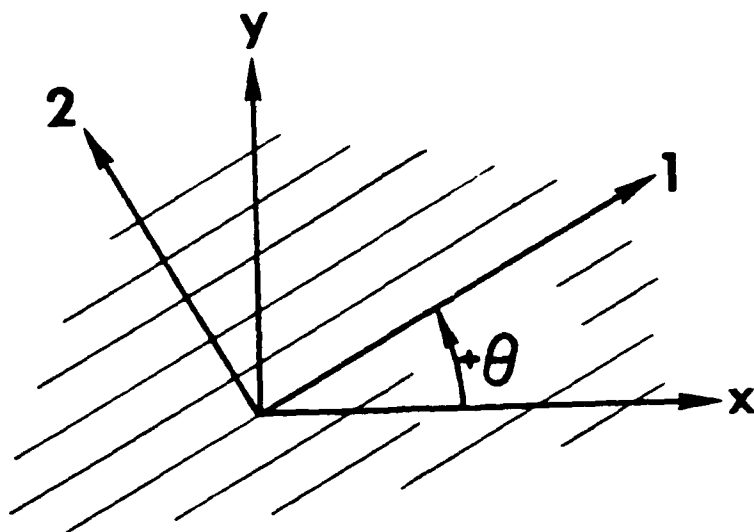
Figure 2. Rotation of principal axis from an arbitrary axis system (Jones 1975:48)

E_1 , E_2 , G_{12} , and ν_{12} are the orthotropic material constants of the principal axis system found by experimentation or by using equations (1) through (4). The angle, θ , is the angle shown in Figure 2. The terms $\eta_{xy,x}$ and $\eta_{xy,y}$ are the coefficients of mutual influence, and they characterize shearing in the xy plane caused by a normal stress in the x and y directions respectively.

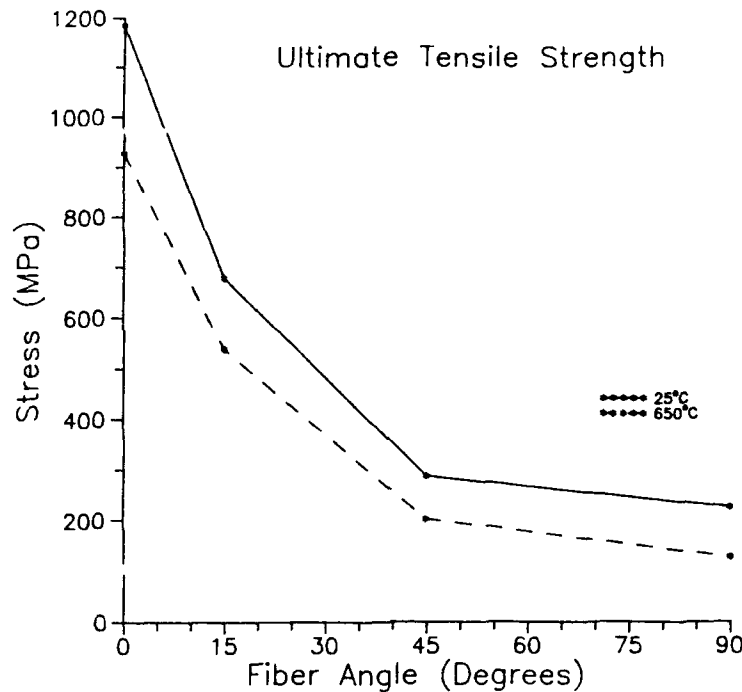
Figure 14. Tensile strength of SCS-6/Ti-24Al-11Nb.

Unnotched Tensile Strength. The room temperature ultimate tensile strength of SCS-6/Ti-24Al-11Nb varies from a maximum of 1185 MPa for the $[0^\circ]_8$ layup to 225 MPa for the $[90^\circ]_8$ layup. The elevated temperature ultimate tensile strength varied from 928 MPa for the $[0^\circ]_8$ layup to 126 MPa for the $[90^\circ]_8$ layup. These results are shown graphically in Figure 14.

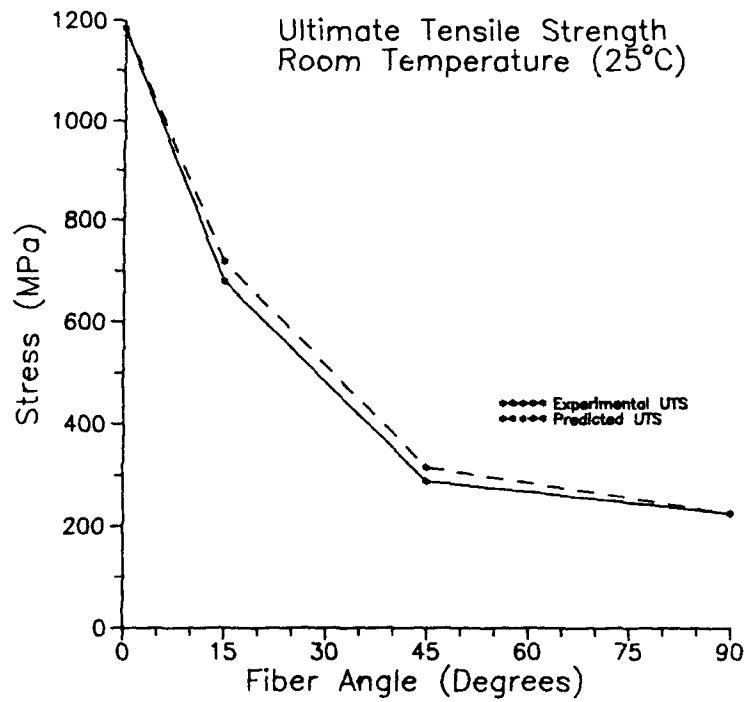
Figure 15. Experimental and predicted tensile strength at 25°C.

generated by the Tsai-Wu failure theory is shown in Figure 15 and Figure 16. The experimental failure strengths closely match the theoretical failure strengths at both room and elevated temperatures. The small variations between the theoretical and experimental curves might be diminished by accurately measuring the shear strength of the composite and by determining the value of the Tsai-Wu interactive term, F_{12} .

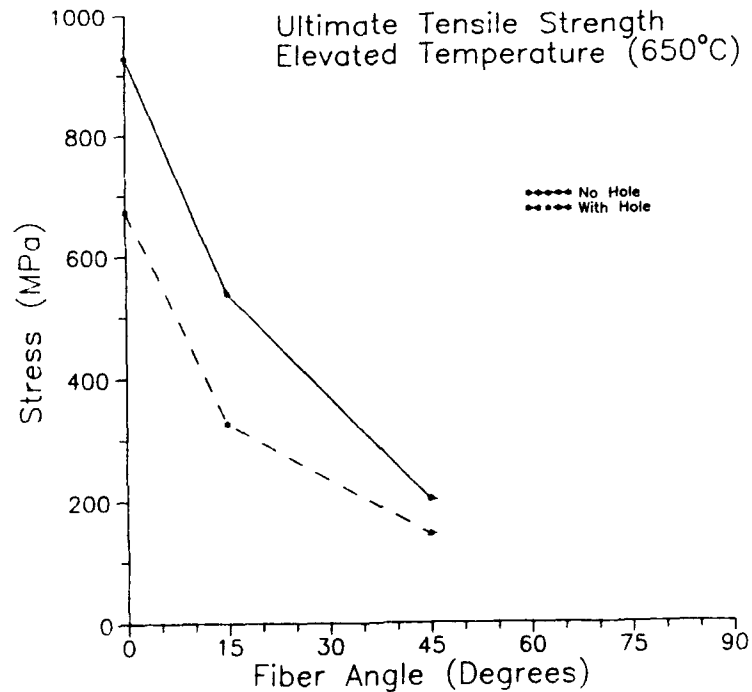
Figure 18. Tensile strength of notched and unnotched SCS-6/Ti-24Al-11Nb at 650°C.

the normalized strengths of the notched specimens are still about 10% less than the unnotched strength for the 0° and 15° fiber orientations. The hole is having an effect other than subtracting load bearing area, but one not nearly as large as predicted by the stress concentration theories. Whitney discussed this phenomenon as it occurred in glass/epoxy composites (Whitney 1974). He demonstrated a direct relationship between hole size and failure strength for hole diameters less than 25.4 mm. Further investigation of the relationship between failure strength and hole size in SCS-6/Ti-24Al-11Nb is worth consideration.

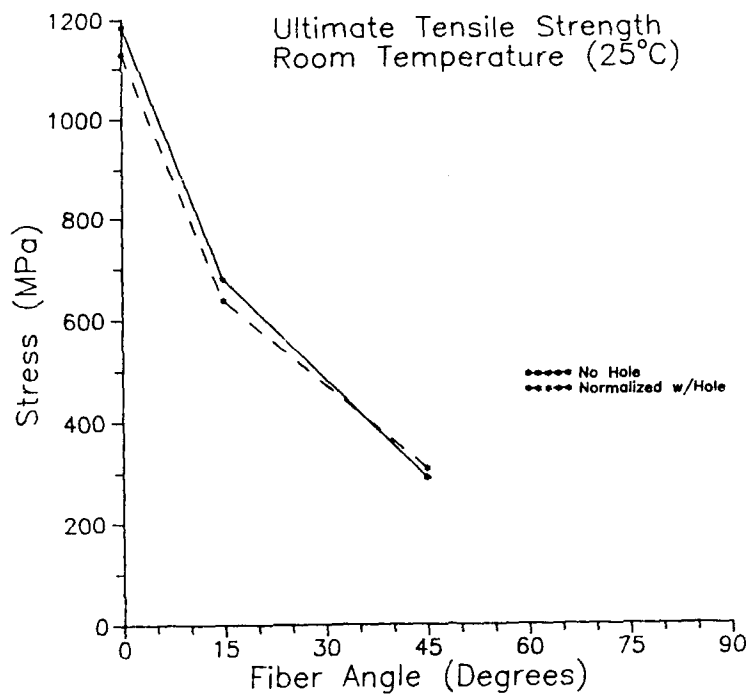
Figure 19. Normalized tensile strengths at 25°C.

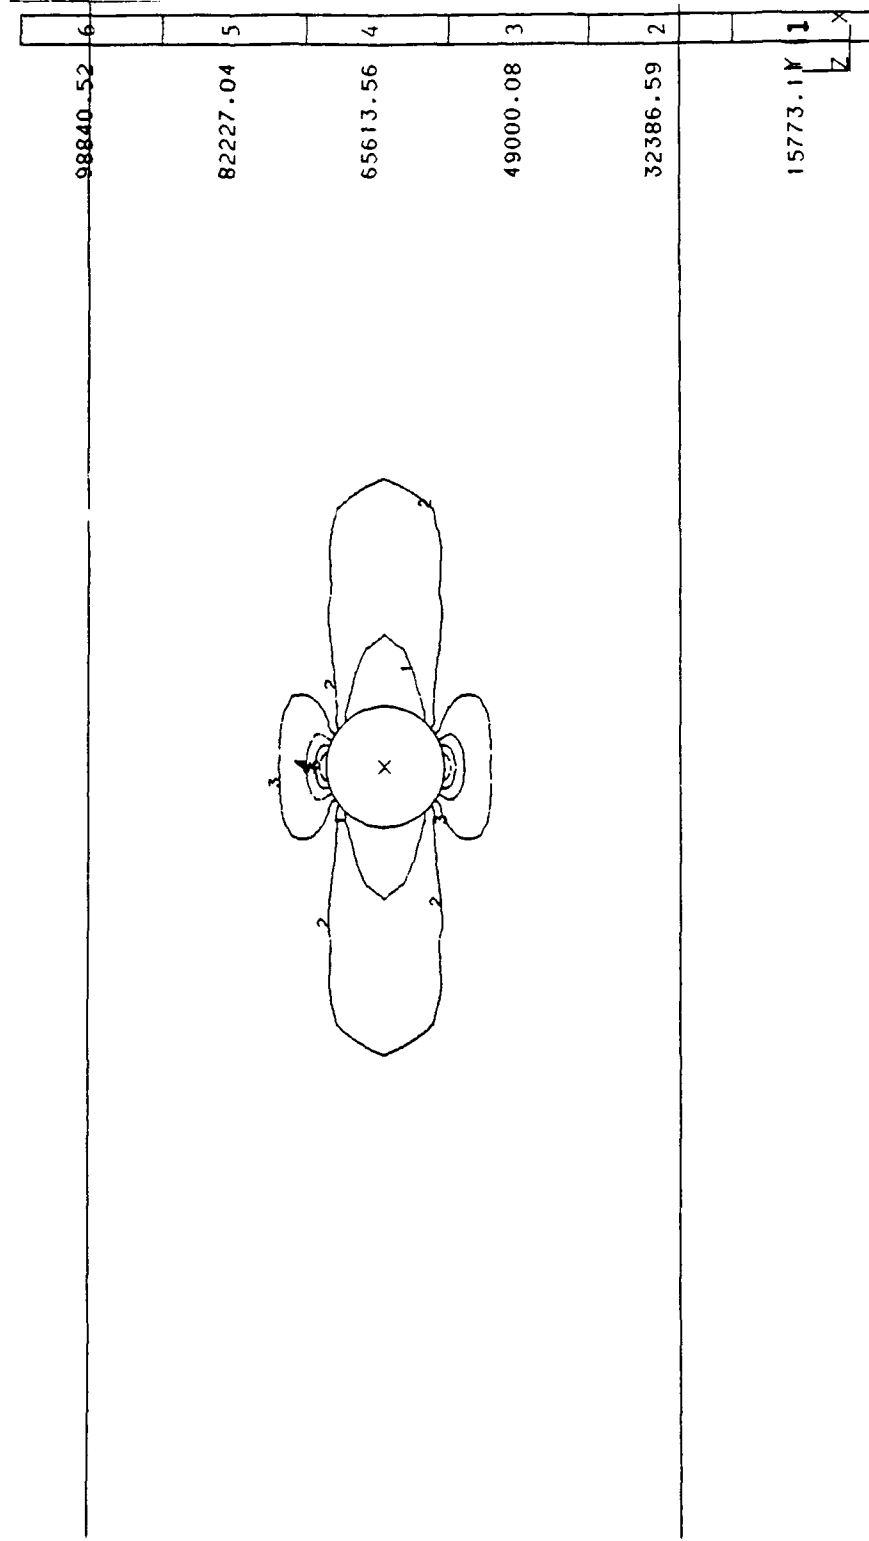
Figure 21. Axial stress in $[0^\circ]_8$ layup (values in ksi).

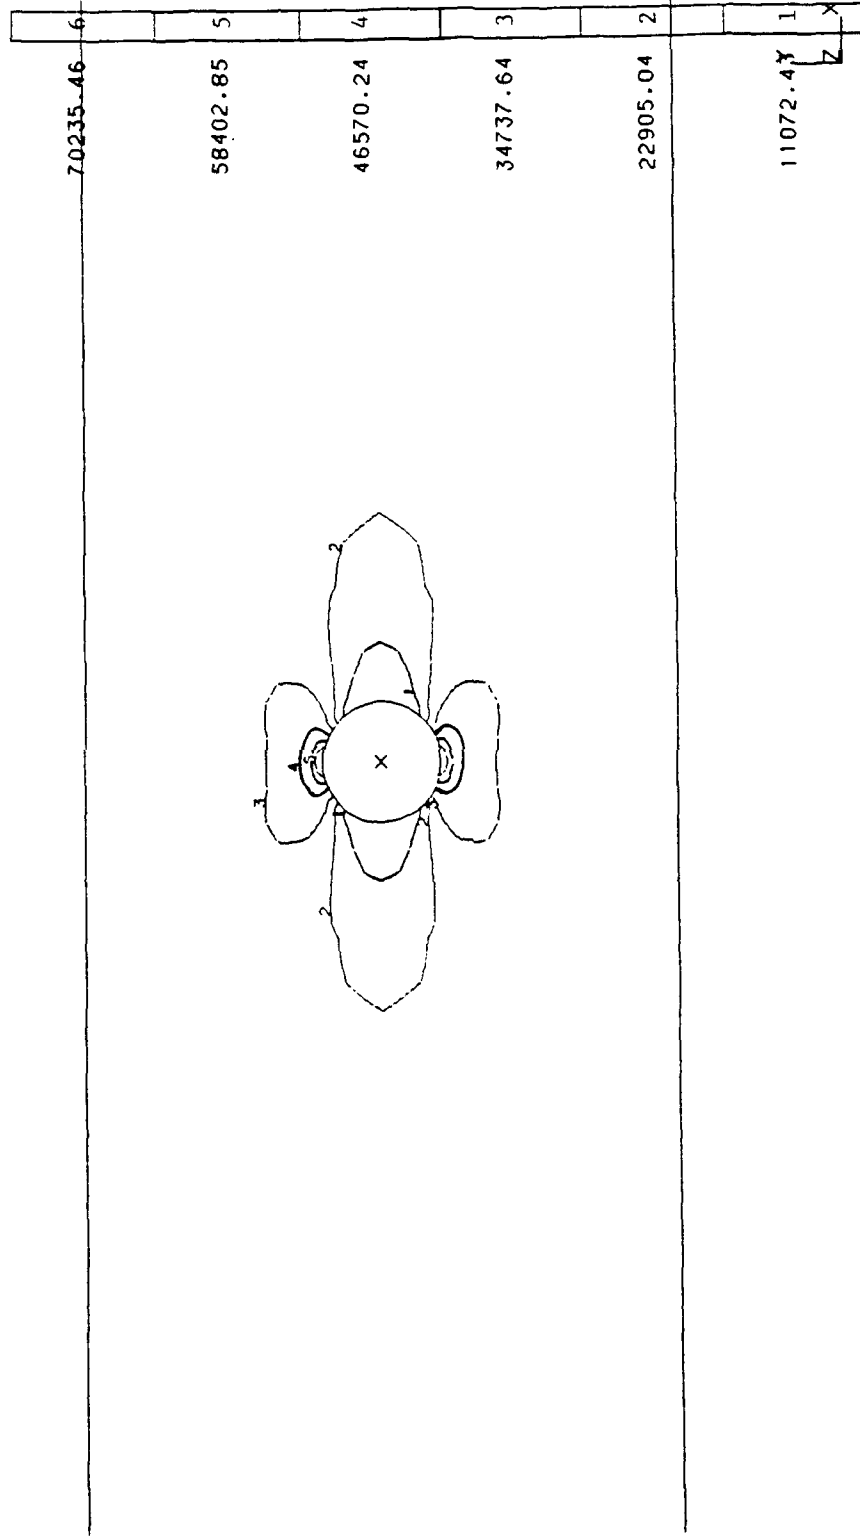
Figure 22. Axial Stress in $[15^\circ]_8$ layup (values in ksi).

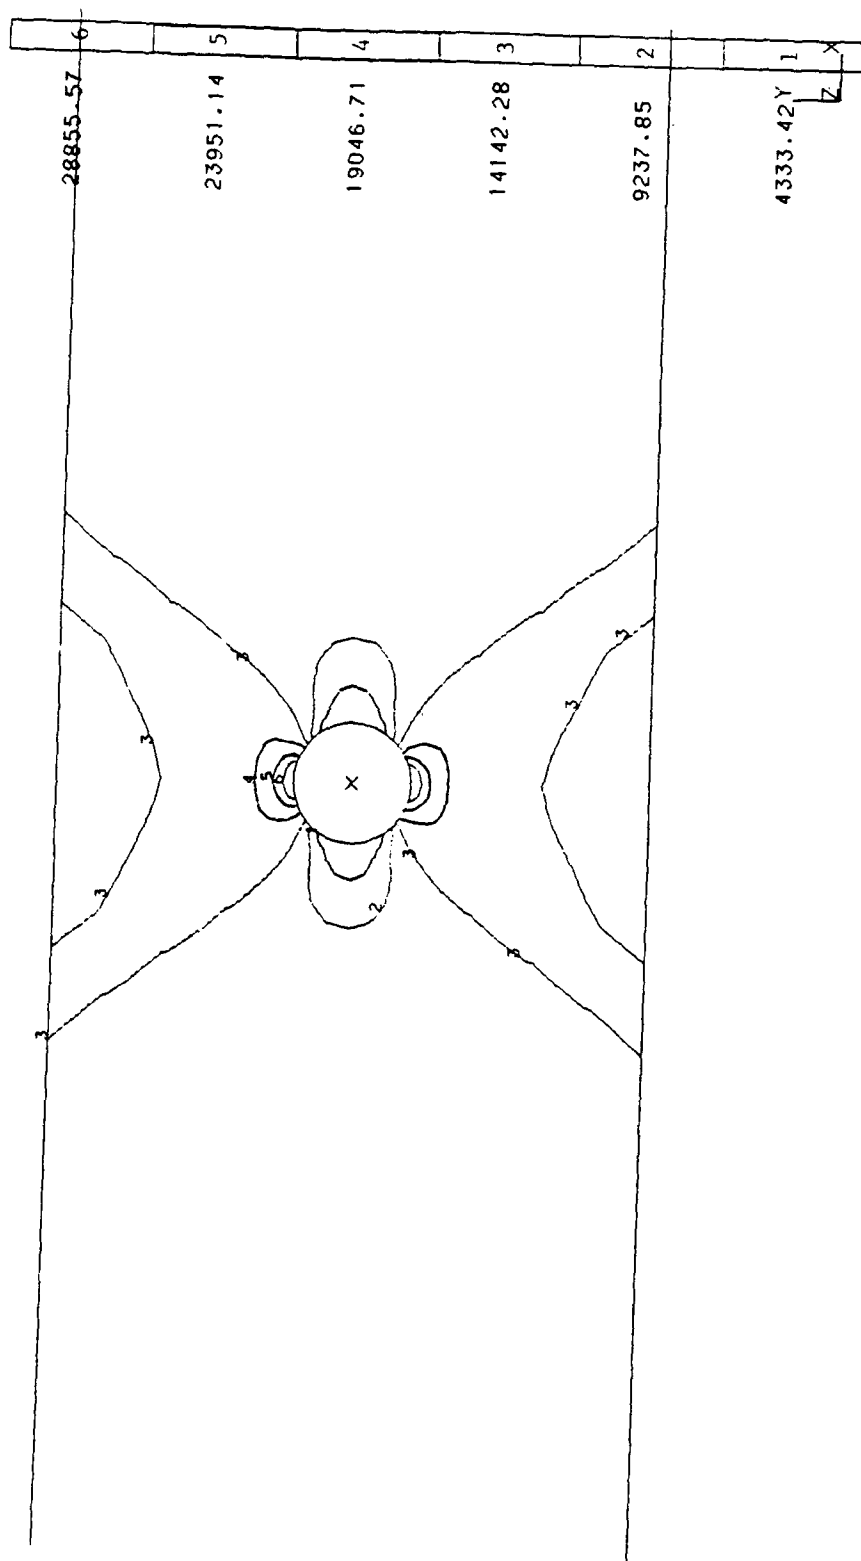
Figure 23. Axial stress in $[45^\circ]_8$ layup (values in ksi).

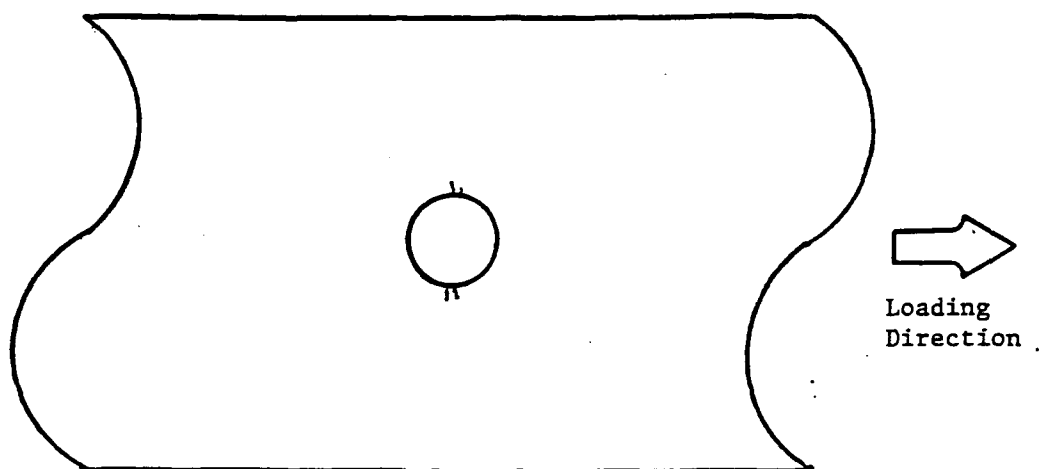
Figure 24. Cracks appearing on surface of $[0^\circ]_8$ specimen.

Zero degree fiber orientation. This specimen was the first loaded to 255 MPa and then to 414 MPa, the point of nonlinearity measured by the extensometer. No surface damage was noted. As the third loading cycle neared 855 MPa, the 95% UTS point, a very small crack appeared on the surface near the edge of the hole. This crack, oriented perpendicular to the loading direction, did not close when the load was reduced prior to unloading the specimen for X-rays. Three more very small cracks appeared near the edge of the hole between 95% and 99% UTS. These very fine cracks were each less than 1/10 of the hole diameter and did not seem to grow after they appeared. See Figure 24. No further damage was observed prior to failure.

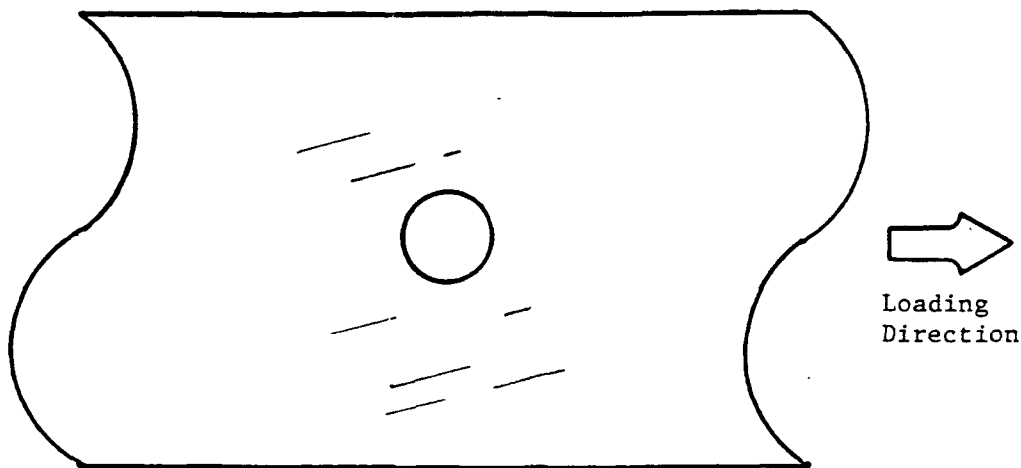
Figure 25. Cracks appearing on surface of $[15^\circ]_8$ specimen.

Fifteen degree fiber orientation. No damage appeared during loading to 190 MPa where the finite element model predicted yielding at the hole. Further loading revealed no damage until near the extensometer nonlinearity of 400 MPa. At this load a series of thin crack-like lines developed on the specimen's surface. See Figure 25. These cracks were approximately 1.5 mm long and parallel to the fiber direction of the specimen. They did not close when the load was reduced to zero. More of these crack lines appeared when the load was increased above 400 MPa toward 480 MPa (95% UTS), but they did not grow longer. The specimen failed at 498 MPa, prior to the 99% UTS load of 503 MPa.

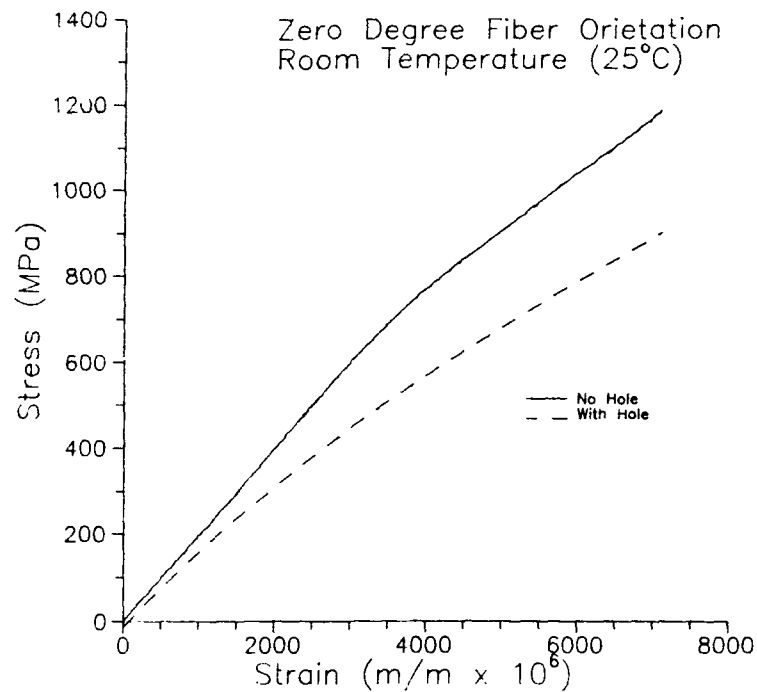
Figure 29. Stress-strain plot of $[0^\circ]_8$ layup at 25°C.

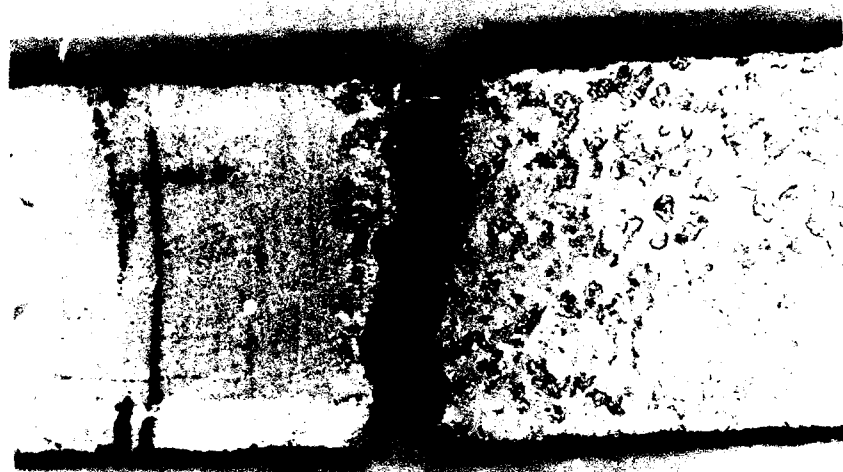
Figure 30. Fracture of $[0^\circ]_8$ specimens (top) unnotched (bottom) notched.

A macroscopic view of the notched and unnotched fracture is shown in Figure 30. Little necking is evident and the fracture surface is perpendicular to the fibers. Examining the fracture surface with a scanning electron microscope (SEM) revealed a brittle fracture of the fibers and matrix with little fiber pull out. Figure 31 shows two views of the unnotched specimen, while Figures 32 and 33 show views of the notched specimen's

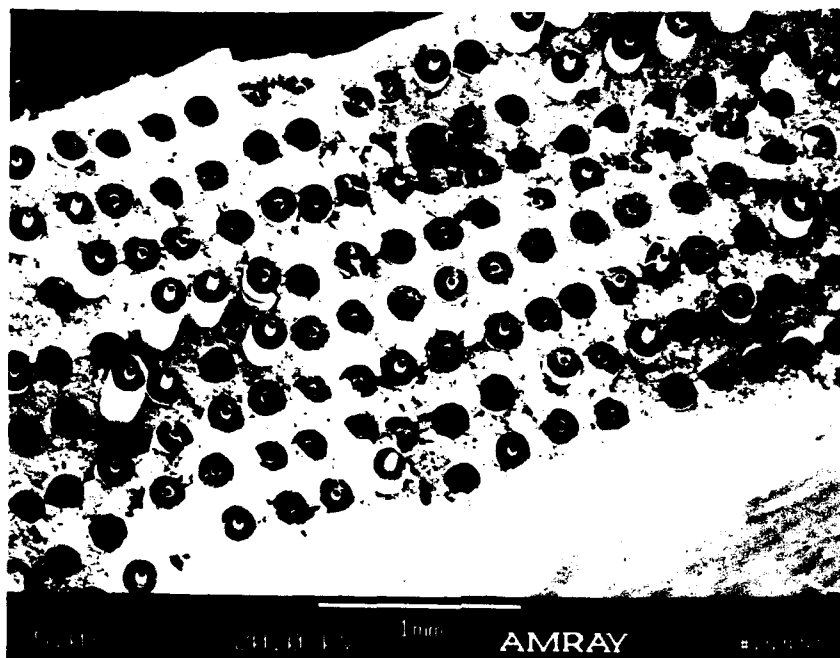
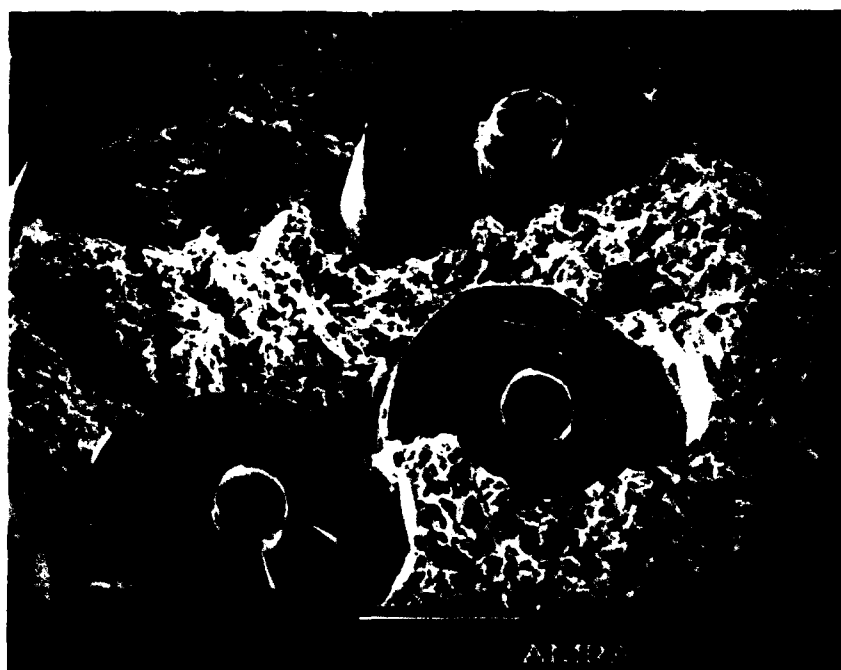
Figure 31. Fracture surface of unnotched $[0^\circ]_8$ specimen.

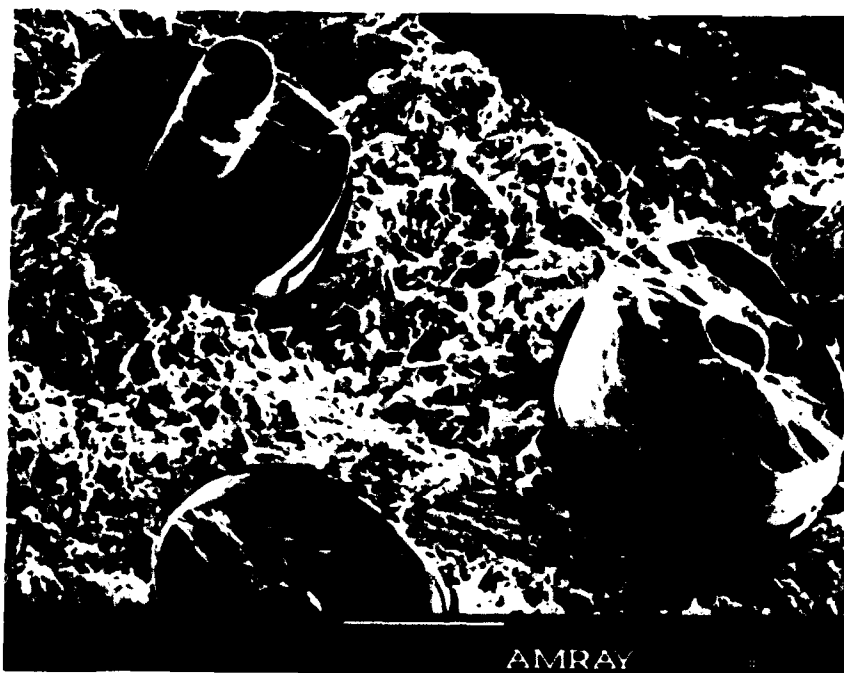
Figure 32. Fracture surface of notched $[0^\circ]_8$ specimen near hole.

fracture surface near the hole and away from it. No differences exist between the fracture surface near the hole and away from it.

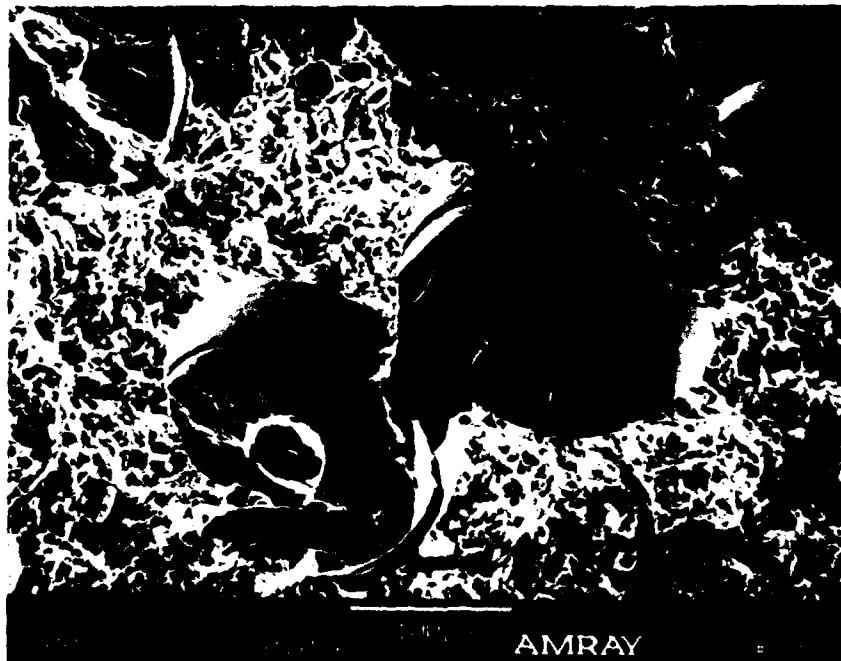
Figure 33. Fracture surface of notched $[0^\circ]_8$ specimen away from hole.

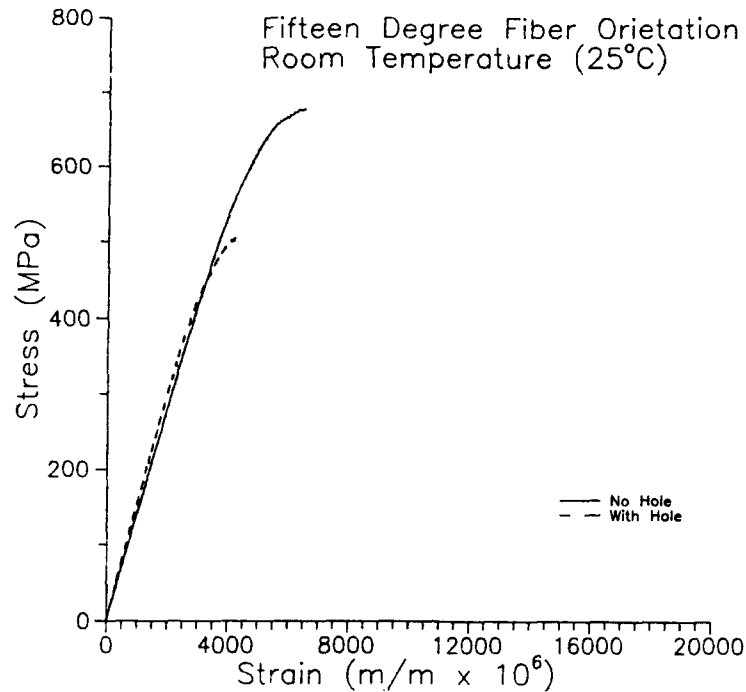
Figure 34. Stress-strain plot of $[15^\circ]_8$ layup at 25°.

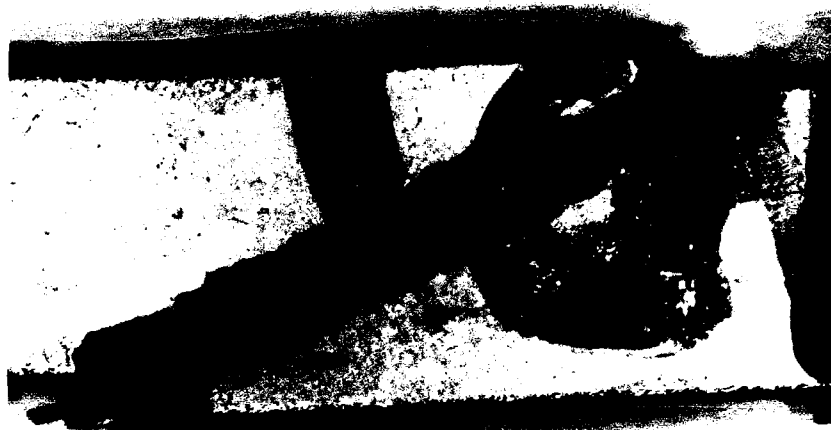
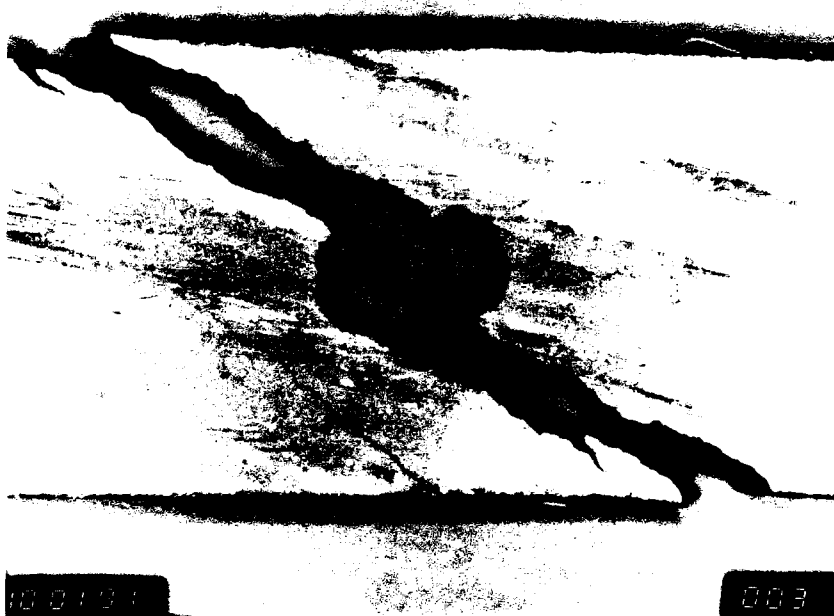
Figure 35. Fracture of $[15^\circ]_s$ specimens (top) unnotched (bottom) notched.

than 90° from it. The SEM magnified views of the fracture surfaces suggest a brittle fracture of the matrix after the fiber matrix interface has failed. The steps occur when a fiber breaks and the matrix can cleave perpendicular to the loading axis. This is particularly evident in Figures 36 and 37, which show the fracture surface of the unnotched and notched specimens respectively. The fibers and matrix separate very cleanly as seen in Figure 38. The fiber surfaces are virtually undamaged as are the channels in the matrix. The fibers at the left of Figure 36 (top) are held in place by the matrix at only a few points. No differences exist between the notched and unnotched fracture surfaces, and little fiber pull out is evident.

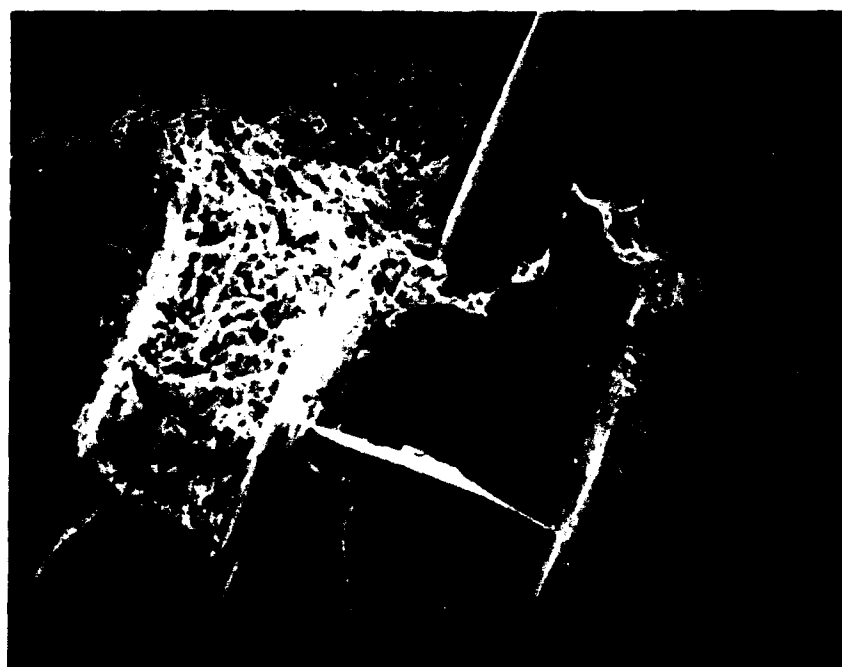
Figure 36. Fracture surface of unnotched $[15^\circ]_8$ specimen.

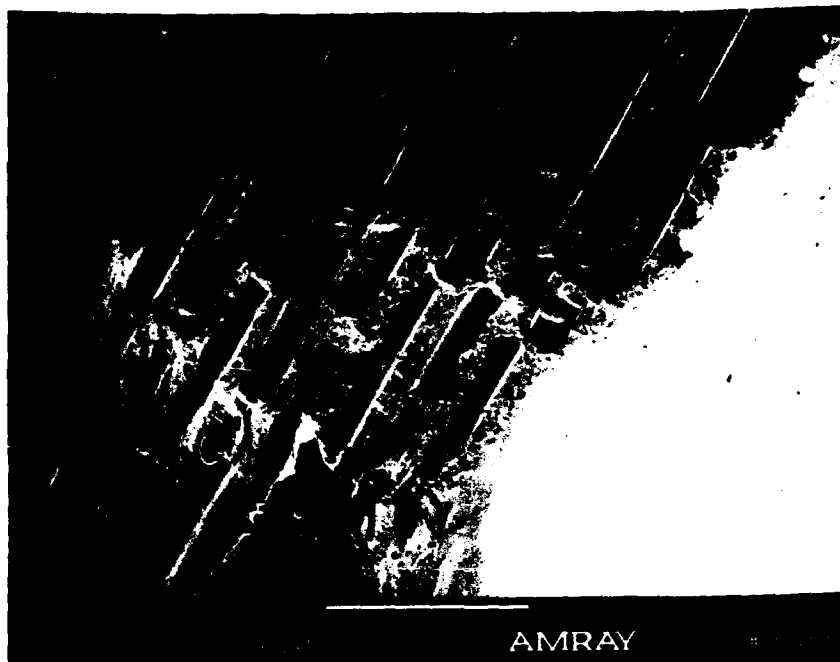
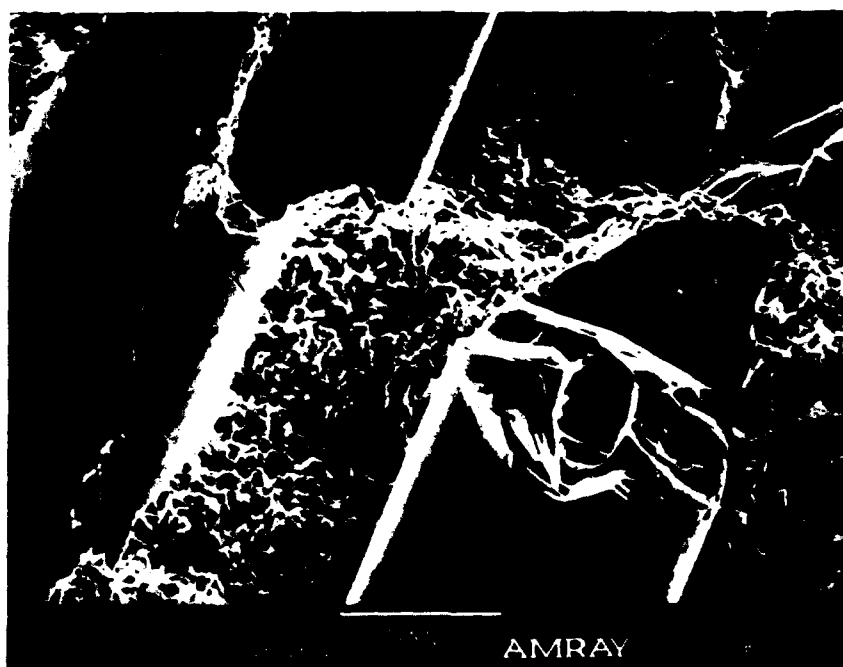
Figure 37. Fracture surface of notched $[15^\circ]_8$ specimen near hole.

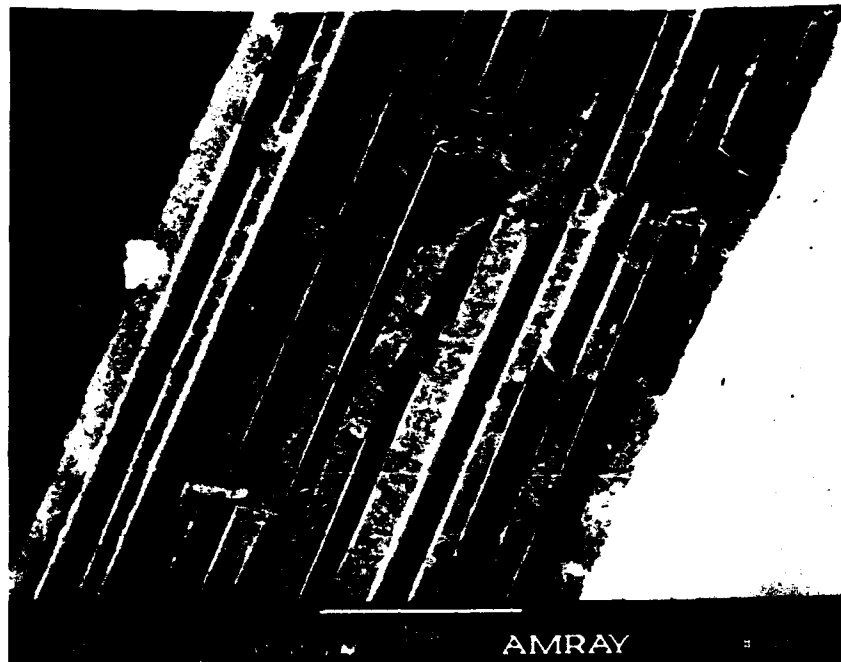
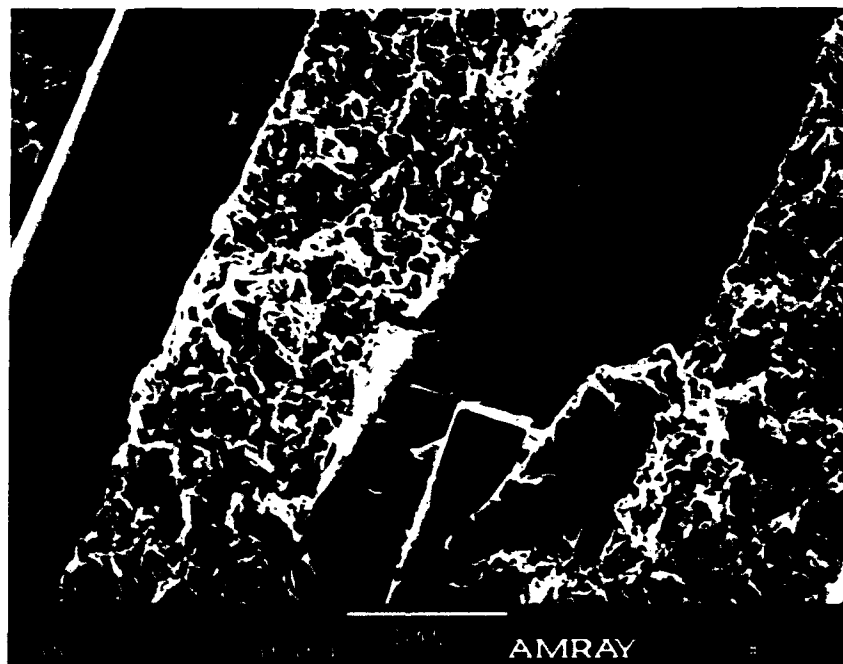
Figure 38. Fracture surface of notched $[15^\circ]_8$ specimen away from hole.

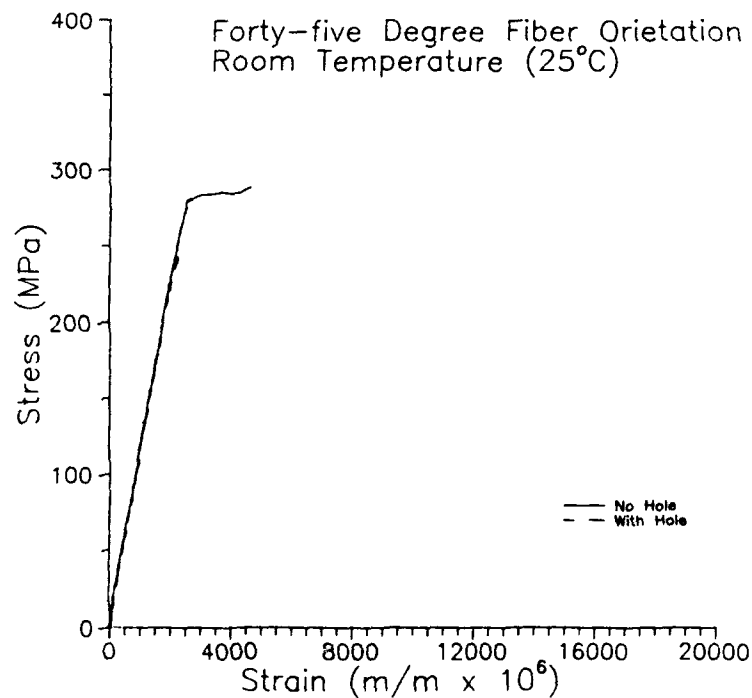
Figure 39. Stress-strain plot of $[45^\circ]_8$ layup at 25°C.

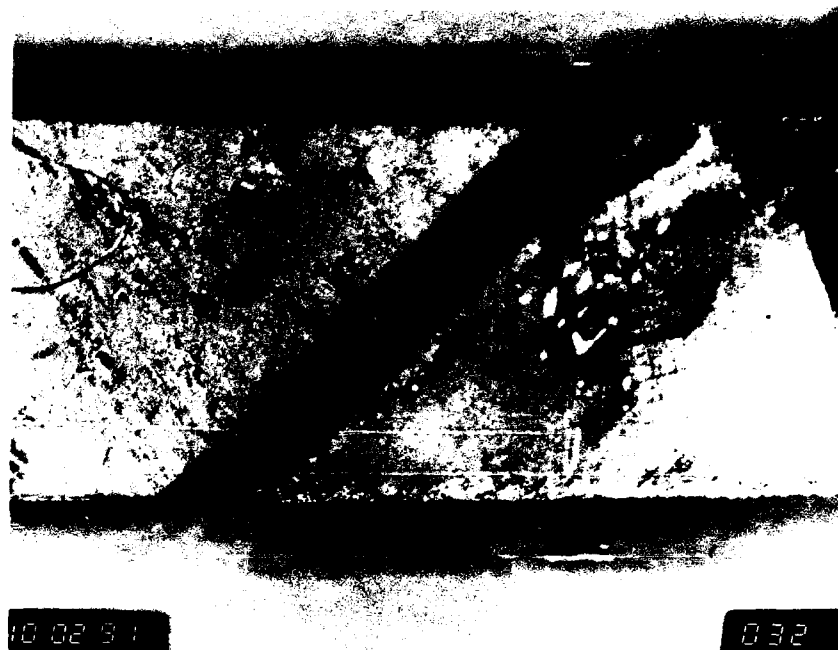
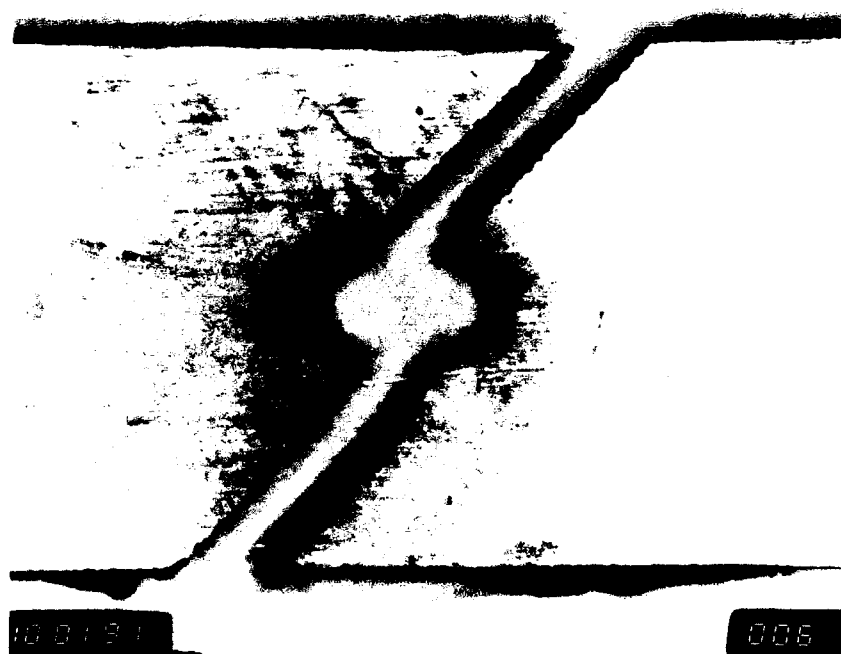
Figure 40. Fracture of $[45^\circ]_R$ specimens (top) unnotched (bottom) notched.

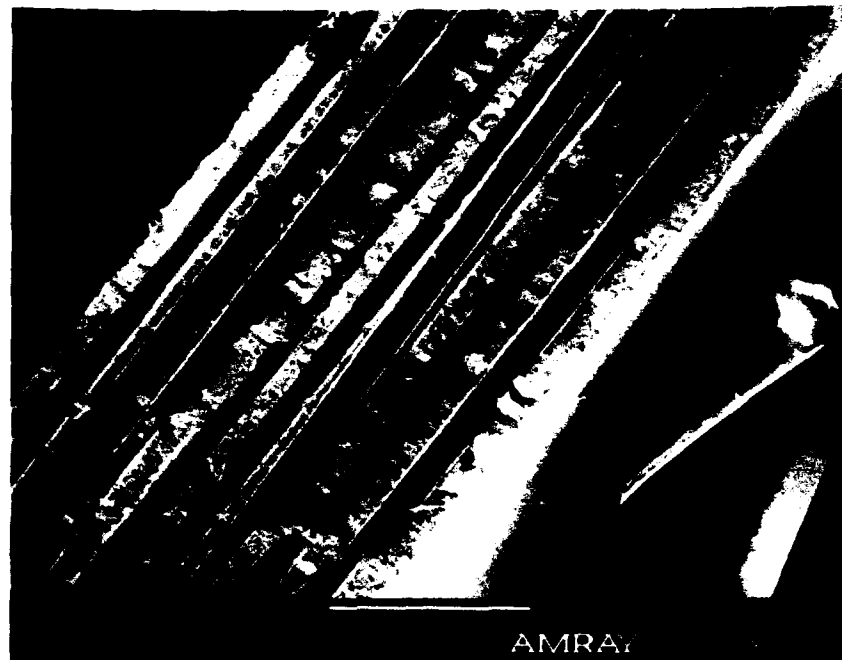
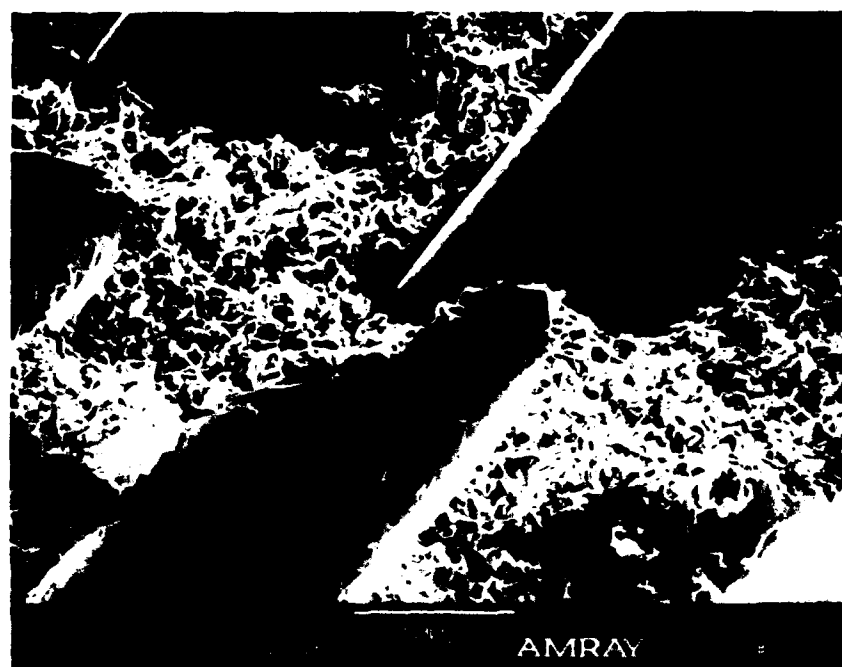
Figure 41. Fracture surface of unnotched $[45^\circ]_s$ specimen.

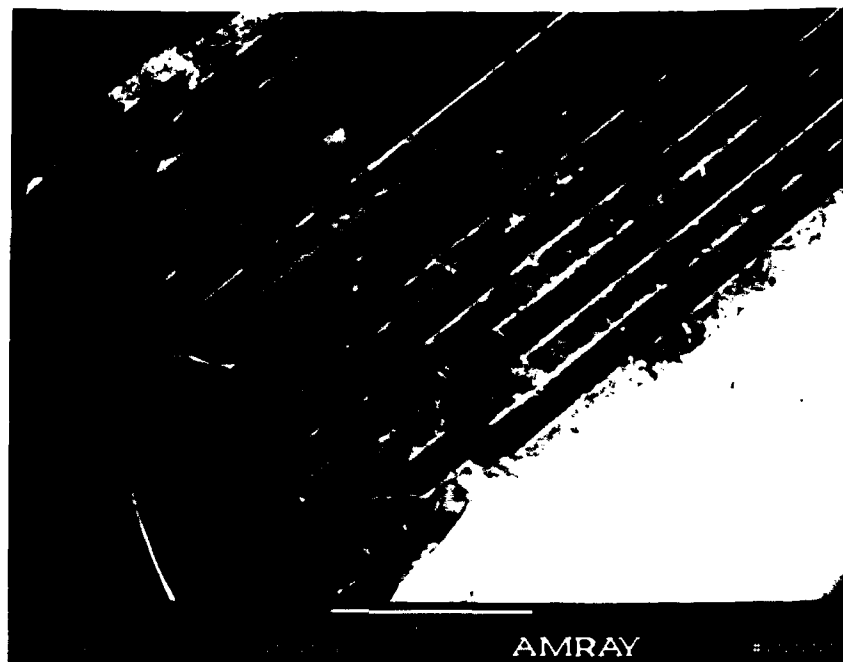
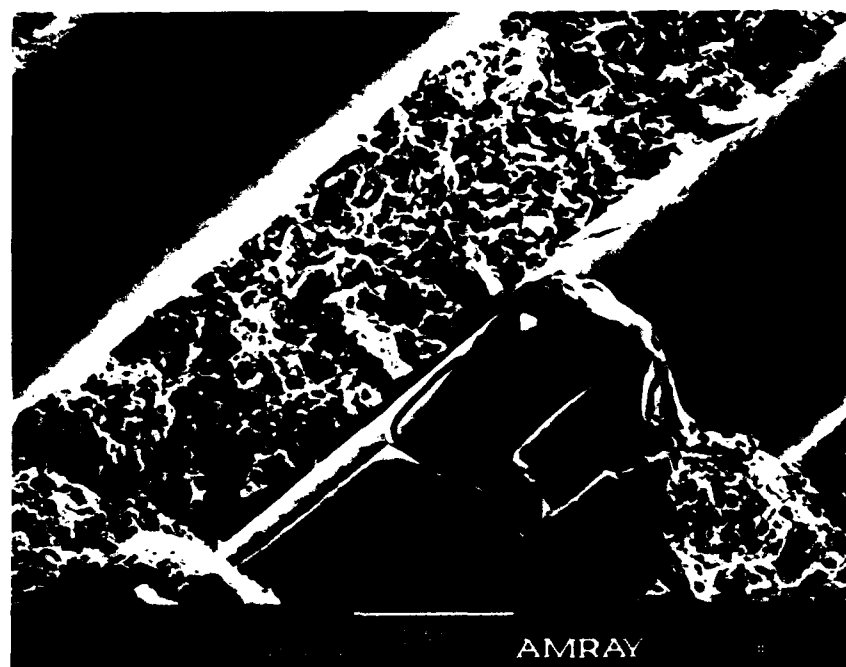
Figure 42. Fracture surface of notched $[45^\circ]_s$ specimen near hole.

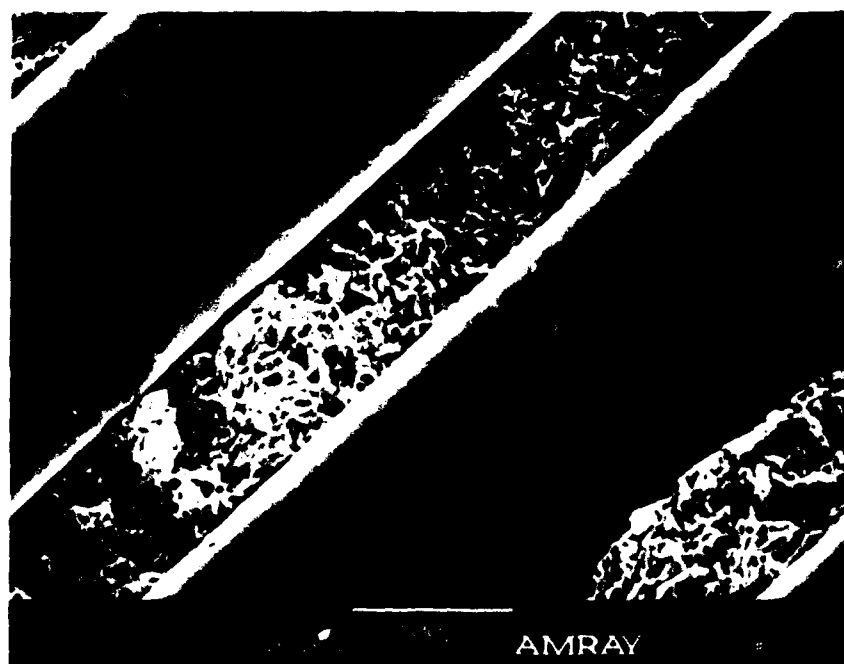
Figure 43. Fracture surface of notched $[45^\circ]_s$ specimen away from hole.

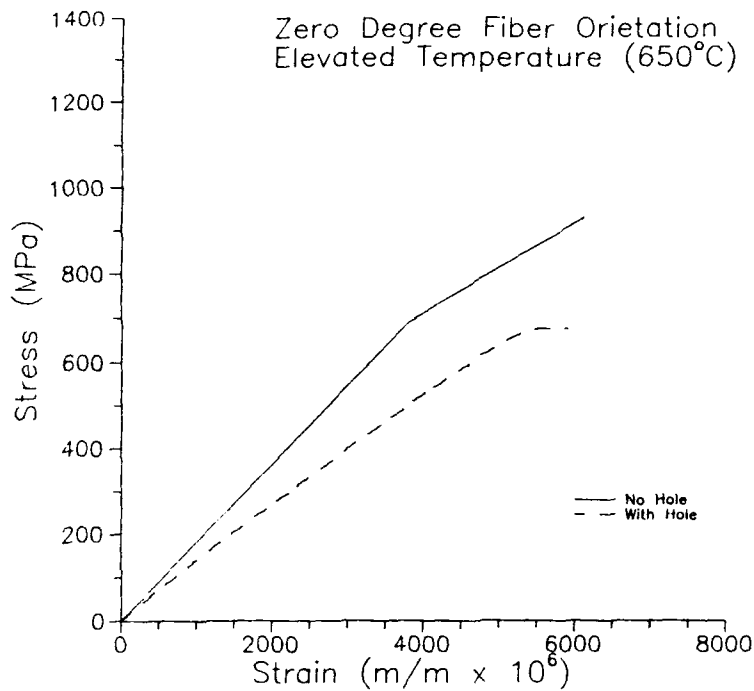
Figure 44. Stress-strain plot of $[0^\circ]_8$ layup at 650°C.

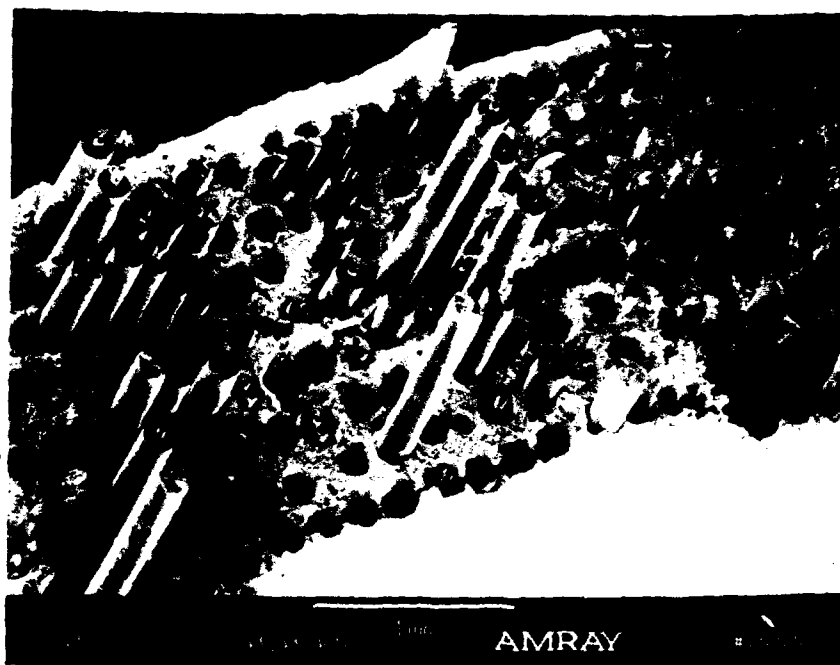
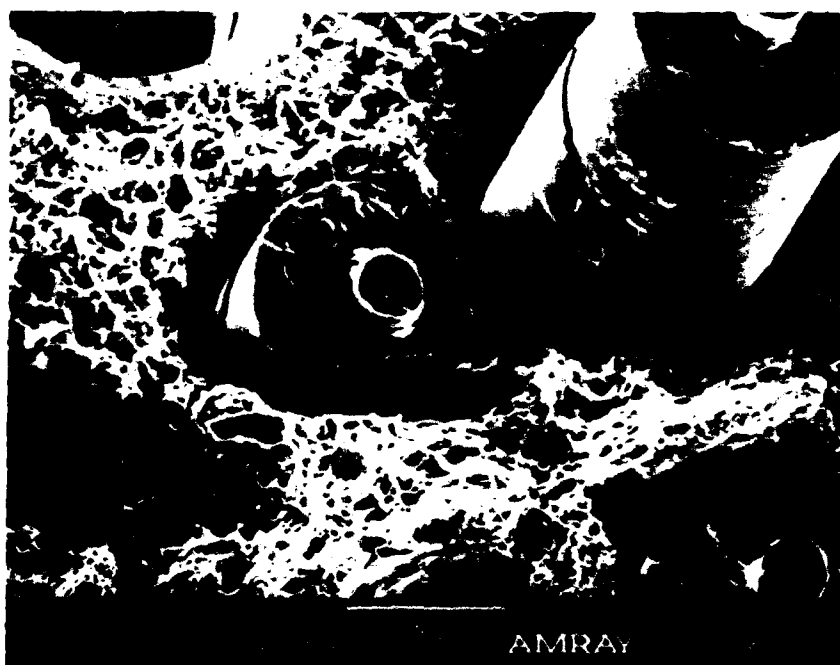
Figure 46. Fracture surface of unnotched $[0^\circ]_s$ specimen.
